# DISTAL MIGRATION OF THE RODS OF A CONSTRAINED POLYAXIAL PEDICLE SCREW SYSTEM

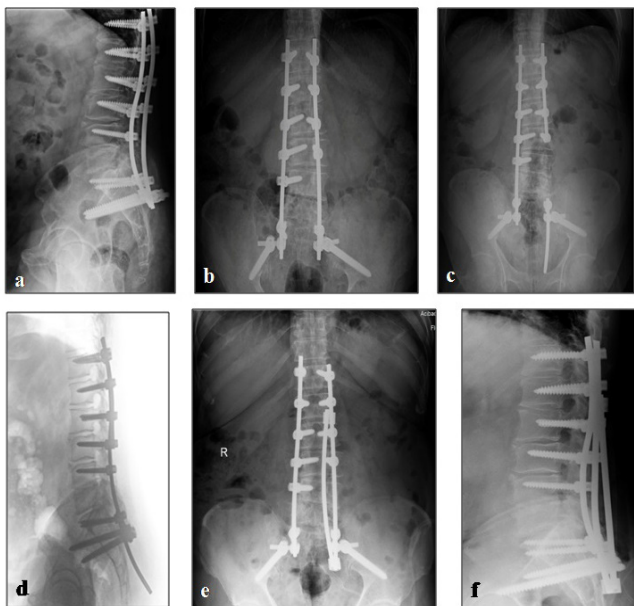
follow-up, lumbar-sacral radiographs revealed a broken left rod now lodged at the gluteal area due to caudal migration (Figure 1c, d). On further questioning, the patient reported some mild aching pain over his left buttock area especially with sitting, but denied any recent strenuous activity. There was no evidence of fusion yet at the instrumented levels. He subsequently underwent a revision surgery of his broken left rod with an additional bypass rod at the left side (Figure 1e, f). Intra-operatively, all the screw caps on the left side were loose. They appeared to be well centered but had backed off by one or two turns allowing the rod to slide down. The screws on the right side were tight. There was no evidence of infection or metallosis. Swabs for cultures were taken and all came back negative for infection.

**Figure 1.** Early post-operative X-ray, AP (a) and lateral view (b), a repeat X-ray at three months AP (c) and lateral (d) views showing a caudally migrated left rod. X-rays after revision surgery, AP (e) and lateral (f) views

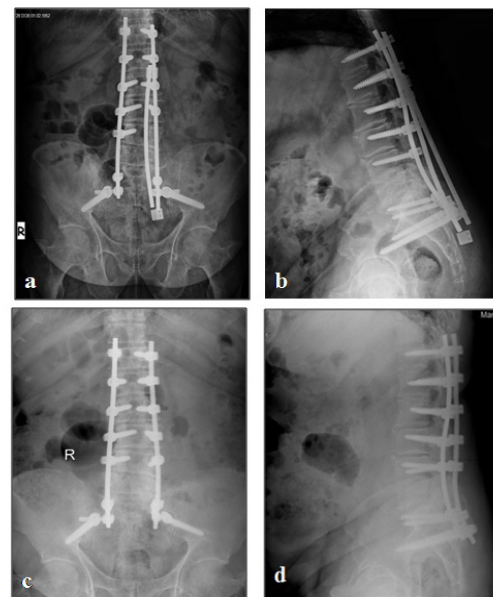
Twelve months after his second operation, “Case 1” presented to his local medical facility again complaining of left gluteal swelling and redness. According to accompanying notes, there was no evidence for local infection or gluteal abscess. Radiographs taken revealed a left sided distal domino failure and had caudally migrated and lodged at his left gluteal area (Figure 2a, b). Similarly, there was no history of recent trauma or strenuous activity. A third operation was subsequently performed for rod and screws exchange with another spinal instrumentation system (CD Horizon Engage 6.35 Spinal System, Medtronic, Minneapolis, MN USA) (Figure 2c, d). Intra-operative findings were strikingly similar to his previous surgery. Right rod was intact, screw caps on the left sided were well centered but had backed off one or two turns. There was no evidence of

**Figure 2.** One year after post revision surgery showing caudally migrated domino AP (a) and Lateral (b) X-rays views. Rod and screws exchange with another spinal instrumentation system AP (c) and Lateral (d) X-rays views

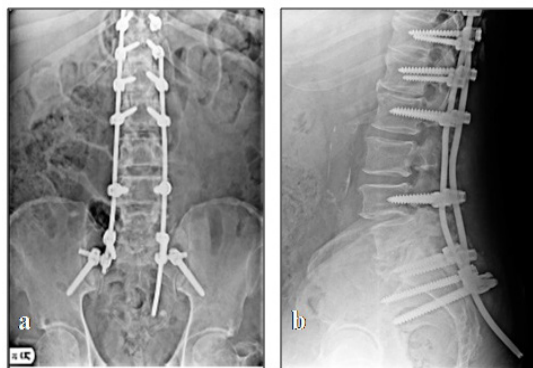
**Figure 3.** Post-operative X-rays AP (a) and Lateral (b) subsequent sequential failure of fixation with rod migration.
