An Unusual Cause of Electrocardiographic Artefact: A Patient's Warming Blanket

Gaurav Misra ^(D), Sanjay Dhiraaj ^(D), Aditya Kapoor ^(D), Puneet Goyal ^(D) Sanjay Gandhi Post Graduate Institute of Medical Sciences, Lucknow, India

Cite this article as: Misra G, Dhiraaj S, Kapoor A, Goyal P. An Unusual Cause of Electrocardiographic Artefact: A Patient's Warming Blanket. Turk J Anaesthesiol Reanim 2018; 46: 161-3.

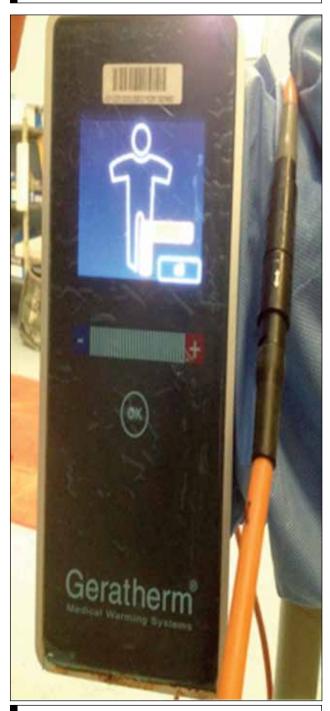
Figure 2. Patient's warming apparatus (Geratherm®)

During this intensive search for the cause of ECG changes, when the patient's warmer (Geratherm[®]) (Figure 2) was turned off, the ECG reverted back to sinus rhythm, concluding that the warmer was causing the artefacts.

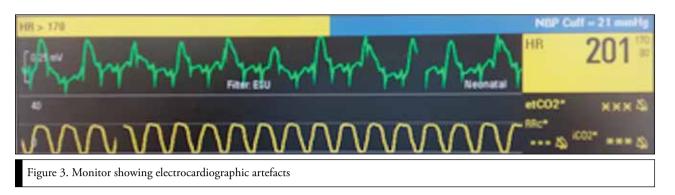
We encountered a similar incidence of ECG artefacts in a 7-year-old boy who was to undergo laparotomy under general anaesthesia. ECG artefacts were similar to those described above (Figure 3). We immediately diagnosed that the arte-

facts occurred because of the warmer, and after switching off the warmer, ECG returned to sinus rhythm (Figure 4).
