The Contribution of SPECT/CT in the Diagnosis of Stress Fracture of the Proximal Tibia

© Berna Okudan, © Nazım Coşkun, © Pelin Arcan

University of Health Sciences, Ankara Numune Training and Research Hospital, Clinic of Nuclear Medicine, Ankara, Turkey

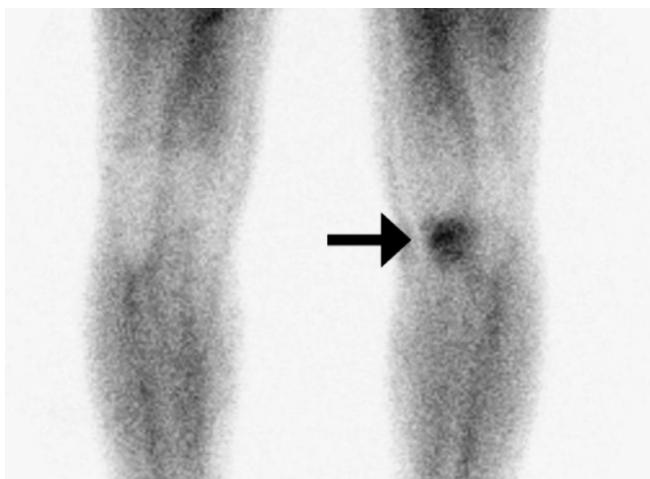
Figure 1. Blood pool phase of 3-phase bone scintigraphy (3-PBS) showing hyperemia in the left knee joint. 3-PBS, revealing the pathologic changes in osseous compartments as early as a few days after the onset of complaints, is a widely used method in the diagnosis of stress fractures.

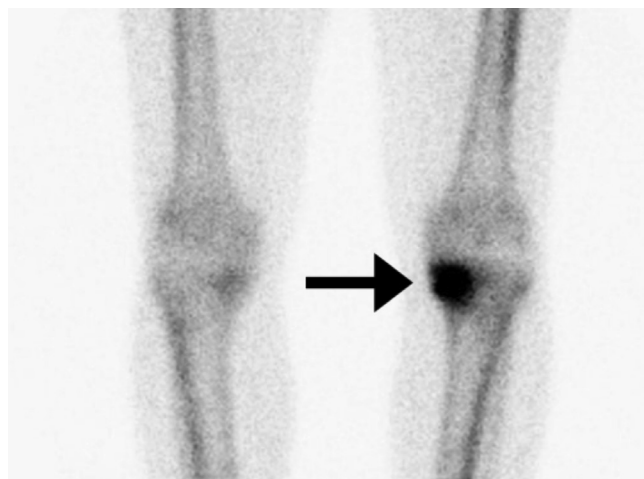
Figure 2. Delayed phase 3-PBS showing increased activity in the left knee joint.

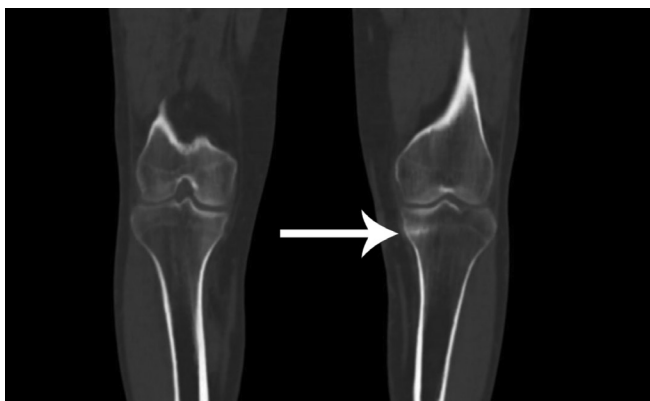
Figure 3. Computed tomography (CT) image from single-photon emission CT (SPECT)/CT fusion study showing a linear fracture in the proximal tibia. While distal and middle third of the tibia are the most frequent sites for stress fractures (almost 50%), stress fractures of the proximal tibia is relatively rare and could be confused with other types of tibial fractures (1). SPECT/CT, which combines the high anatomical resolution of CT with the early-diagnosis capability of SPECT, is an increasingly preferred imaging technique in the diagnosis and follow-up of these patients (2).

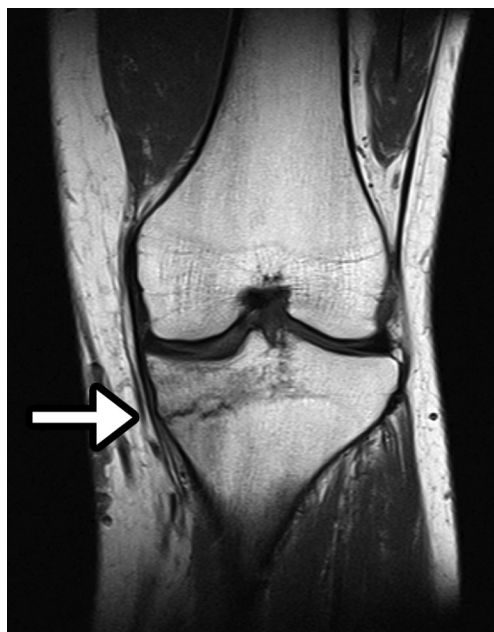
Figure 4. Magnetic resonance image confirming the stress fracture line in the proximal tibia.
