Failure of Constrained Total Hip Arthroplasty with Intact Reinforcement Ring

Case Reports

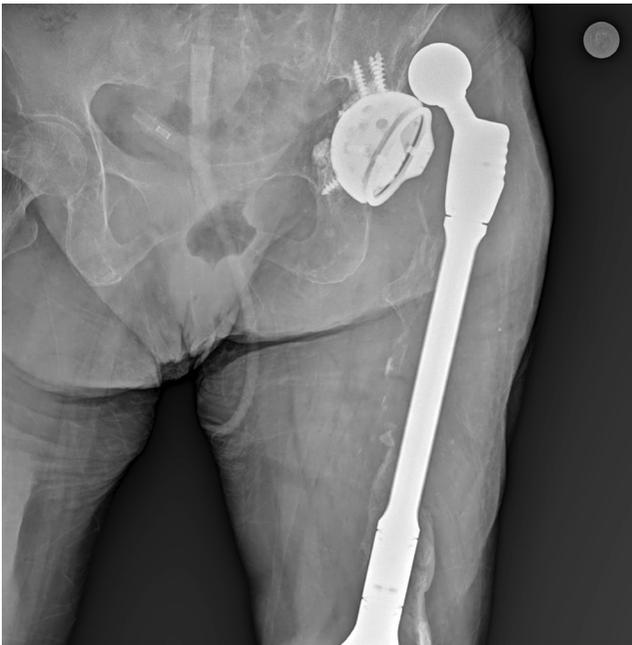
A 72-year-old female patient underwent THA in 2010. One year later, she underwent two-stage revision surgery because of infection. In 2014, she presented to our clinic with infected total hip prosthesis and treated with two-stage revision surgery again. In late 2015 she was admitted with periprosthetic distal femur intraarticular fracture. She underwent total femur prosthesis and constrained hip arthroplasty. Five months later, she presented with dislocated hip with intact reinforcement ring (Figure 1).

Figure 1. Antero-posterior view of the pelvis showing dislocation of the left hip prosthesis with intact reinforcement ring

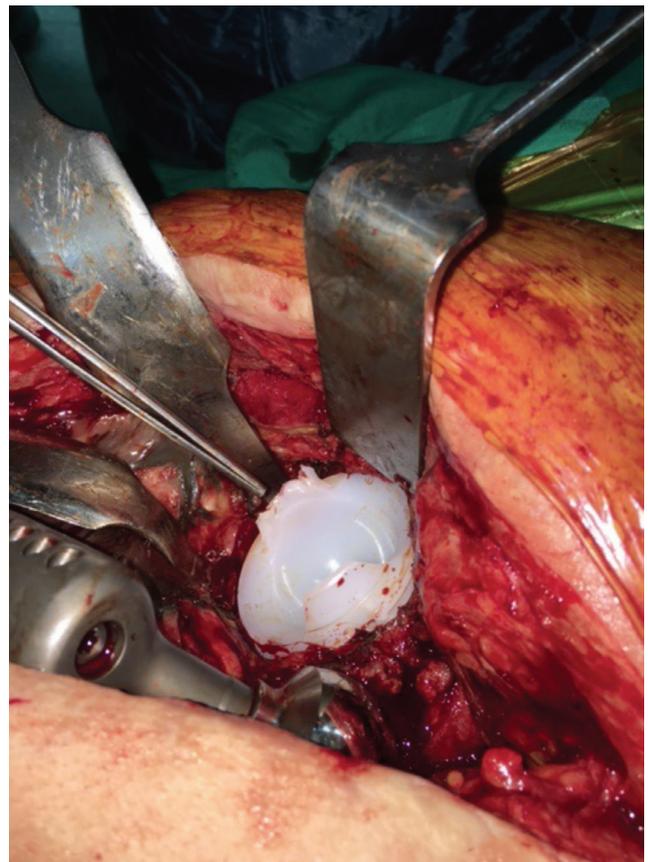
At revision surgery, the retaining fingers of the polyethylene liner were found at the 2-8 o'clock position and the inferior finger was disrupted because of impingement of the femoral head (Figure 2). New constrained liner was adapted to 1-7 o'clock position which is suggested by the manufacturer.

Figure 2. Intraoperative photograph demonstrating malpositioned and disrupted constrained liner

The first case is a patient who was hospitalized for five months because of infection and multiple surgeries. After elimination of infection, revision surgery was performed and the patient returned daily life. The constrained acetabular liner was the source of confidence about stability of the hip. However, unexpectedly, the patient presented with dislocation. There is a risk of dislocation even if the constrained liner is correctly placed. Thoms and Marwin (6) reported a patient with two dislocations of a tripolar constrained acetabular liner caused by impingement. Tufescu and Dust (7) reported two cases of failed constrained THA caused by skirted femoral stem. In our case, we observed impingement because of constrained liner malrotation. The inferior finger of the constrained liner was disrupted. The liner was at the 2-8 o'clock position. A new liner was placed at the 1-7 o'clock position and we gained more range of motion without impingement.

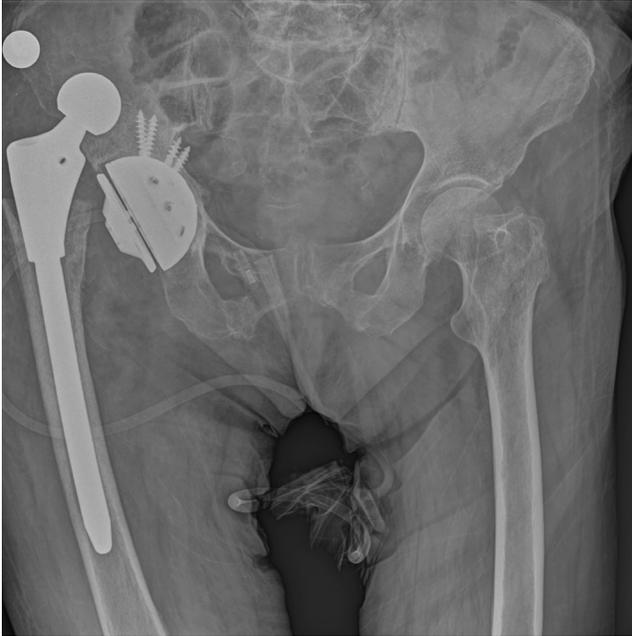
X-rays (Figure 3). We offered revision surgery, but patient preferred to be treated in another clinic.

Figure 3. Antero-posterior view of the pelvis showing dislocation of the right hip with intact reinforcement ring
