Pitfalls in Ventilation Devices

Cite this article as: Sezari P, Nashibi M, Safari F, Dabbagh A, Mottaghi K. Pitfalls in Ventilation Devices. Turk J Anaesthesiol Reanim 2020; 48(5): 417-9.

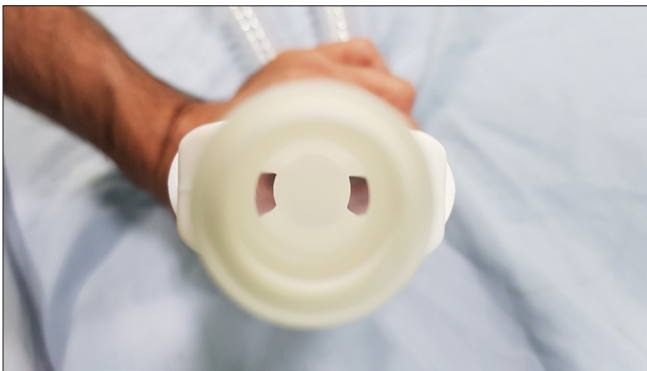
Figure 2. Normal Y-piece with two orifices

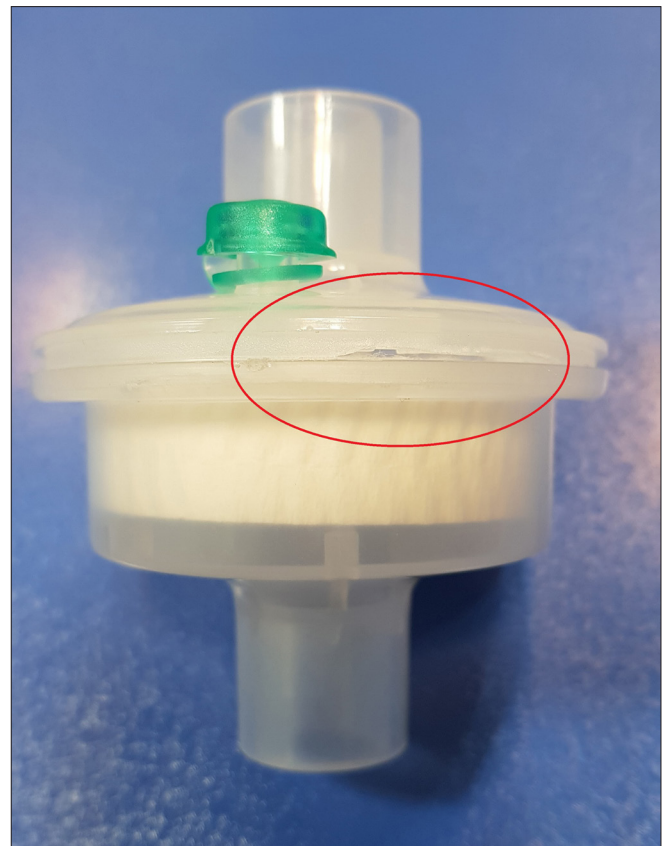
tion with self-inflating bag with the HME filter in place revealed a leakage. On thorough inspection, the ridge of two plastic parts of the HME filter, which should be fitted together, was detached, and air was leaking through the gap (Figure 3). By replacing a new filter, everything came back to normal, and surgery continued to the end and patient emerged without any problem.

Figure 3. Cleavage of plastic fittings between two plastic parts of the HME filter
HME: heat and moisture exchange

There are a handful of articles reporting HME filter obstruction, which made ventilation difficult and resulted in misdiagnosis of bronchospasm (7, 8), but even in these cases with increased PIP, crack and cleavage has not been reported. The problem reported to the manufacturer to be solved for later products.

Every fitting in airway setting is prone to disconnection even inside a single device and must be checked in occasion of ventilation problems.
