Refractory Hypotension Despite High Dose Inotropic Support: An Unusual Cause

Keywords: Central venous catheter, hypotension, ultrasound

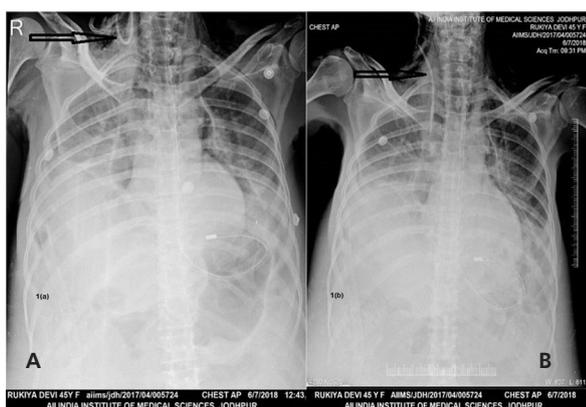
with uterine prolapsed and was planned for cytoreductive surgery. Anaesthesia was induced by experienced anesthesiology team with peripheral venous access as per hospital protocol. After intubation, central venous cannulation was done in IJV by ultrasound (USG) guidance, blood flow was checked in all three ports and 7.5 Fr catheter was fixed at 12 cm by suturing. The duration of surgery was seven hours and patient had 3 episodes of hypotension, which was managed with fluid bolus through peripheral venous access. After the surgery, patient was shifted to ICU for further monitoring. In immediate post operative period, patient required inotropic support, but despite giving inotropes, patient's blood pressure was not able to be maintained. Patient's chest X-ray was done and central line was found to be turning on to itself and going in upwards direction (Figure 1A). Immediately IJV was recannulated with 7.5 Fr

catheter under USG guidance and blood was checked to be coming from all ports. Post procedure X-ray was also done immediately to localize it's position, which was found normal (Figure 1B).

In our case, the angle of the IJV and subclavian vein, facilitated the catheter looping back of itself by pushing the j-shaped tip of the guidewire upward. This bending of catheter led to it's occlusion, although it was put under

Figure 1. A, B) Central venous catheter looping back of itself and after repositioning

USG guidance. This malposition of CVC catheter resulted into a scenario of refractory hypotension despite high dose inotropic support. Kamalipour et al. (7) in their observational study on 116 patients comparing USG and chest radiography for detecting the correct location of CVC, found sensitivity of 98% and specificity of 69% for USG with positive and negative predictive values were 95% and 85%, respectively. They concluded that despite close concordance between USG and chest radiography, USG is not a suitable alternative for standard chest radiography in detecting CVC location. Further they added that USG can be a useful for detecting CVC location on a real-time basis in the operating room because of it's high sensitivity and acceptable specificity. In a recent meta-analysis (8) of 15 studies, bedside USG was found faster than radiography at identifying pneumothorax after CVC insertion and it reduced mean CVC confirmation time by 58.3 minutes. Chui et al. (9) in a recent study on 6.875 patient who underwent USG guided CVC catheter insertion concluded that routine post procedural X-ray is unnecessary.

USG has aided in CVC insertion in many ways. However, fully reliable on USG for localising vein and guiding the needle is not enough and can not prevent malposition of catheter and it can lead to a catastrophic situation. Our message to readers is to scan along the vein to localise the CVC catheter even after it seems apparently normal. We should also not forget the importance of post CVC insertion chest X-ray to visualize it's tip.
