# Porcelain Laminate Veneer Applications in Upper Anterior Region: Case report

In this case report, all stages of treatment, involving porcelain laminate veneer, of a female patient, who was admitted to our clinic with the request of removing the esthetic complaints on her front teeth, was described

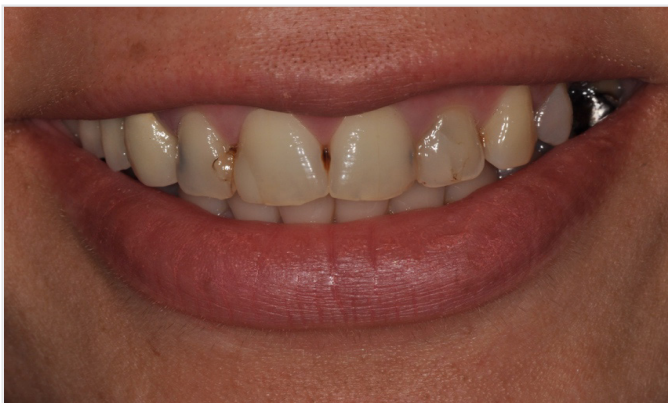
Figure 1. Intra-oral image of the patient before treatment

A 30-year-old female patient was admitted to our clinic because the old composite restorations on her upper front incisors did not meet her esthetic expectations (Figure 1).

An intra-oral examination of the patient revealed that old restorations had lost edge alignment and secondary bruises had formed. After occlusion control, radiographic examination and evaluation of the patient's habits, it was decided to perform laminate veneer restorations on teeth 11-12-21-22 using lithium disilicate glass ceramic material. First, the consent form was taken from the patient. The tooth color was determined by using the Vitapan Classical Shade Guide (Vita Zahnfabrik, Germany) in daylight before the teeth were introduced to the preparation stage. Before starting the preparation, local anesthesia was performed to

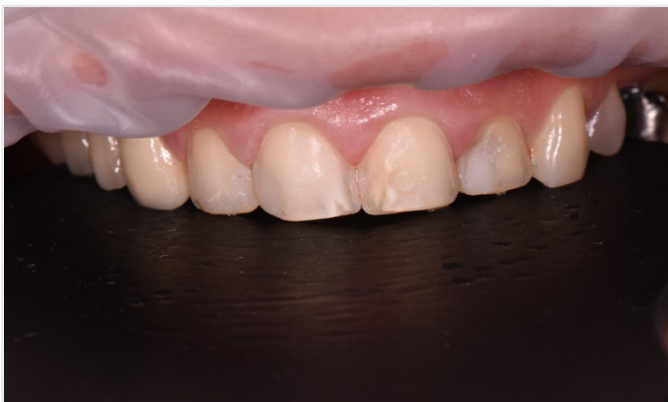
Figure 2. The image of the prepared teeth

the related teeth. After all of the old composite restorations were removed, the rotten tissues were cleaned (1,3). Preparations were made using chamfer frez (G&Z Instruments, Austria), just above the gum, approximately 0.5 mm wide (Figure 2). After gingival retraction cord with the number #00 (Ultradent, A.B.D.) was placed, final cutting was done and lacquer discs (Sof-Lex, 3MEspe, A.B.D.) were used to ensure smooth cutting, Plaster was transferred to the model with occlusal records by making measurement with additional type of silicone measuring agent (Variotime, Kulzer, Germany) after the preparation was completed.

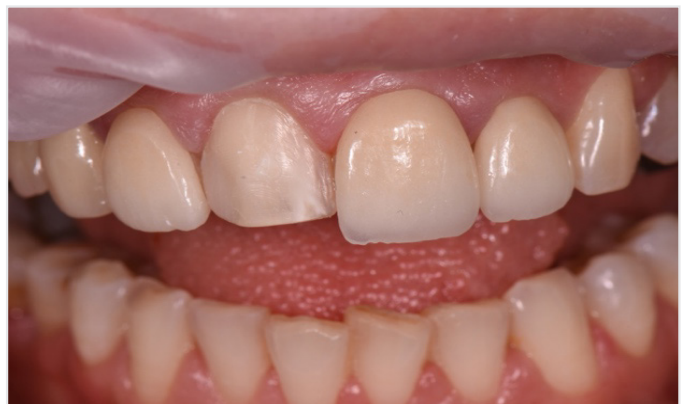
Figure 3. Cementation phase

The cementation process was performed using the Variolink Esthetic LC (Ivoclar,Vivadent, Liechtenstein) set. To check the color harmony before starting the simentation process, the color selection of the bonding cement with the testing cement was made. To the inner surface of the veneers, 10% hydrofluoric acid (Ultradent, A.B.D.) was applied for 20 seconds, then washed, and then dried with veneers air spray. Then cement (Monobond Plus, Ivoclar Vivadent, Liechtenstein) was applied to the veneers for 60 seconds. To teeth surfaces, 37% phosphoric acid (Total Etch, Ivoclar Vivadent, Liechtenstein) was applied for 15 seconds, then washed and dried. Then bonding agent was applied to all tooth surfaces and polymerized with 20 sec light according to the manufacturer's instructions. The bonding cement suitable for tooth color was applied to the inner surface of the veneers and placed on the tooth surface with a slight finger

pressure and initial polymerization was made with a LED light source (Valo, Ultradent, A.B.D) for 3 sec. The residue of the bonding cement was removed, the gingival sulcus was checked with dental floss, glycerin was applied to the gingival margin area and polymerization was completed by applying 40 sec light to each area (Figure 3). Edge alignment of laminate veneers was re-checked with eye and sond and occlusal alignment was re-checked with articulation paper (Figure 4, 5). The patient was called to control laminate veneers at the end of one year. Surface roughness, border alignment and coloration of laminate veneers, and secondary caries were evaluated (Figure 6).No problems were observed between restorations and teeth in terms of edge alignment.The restorations were determined to be esthetically good.

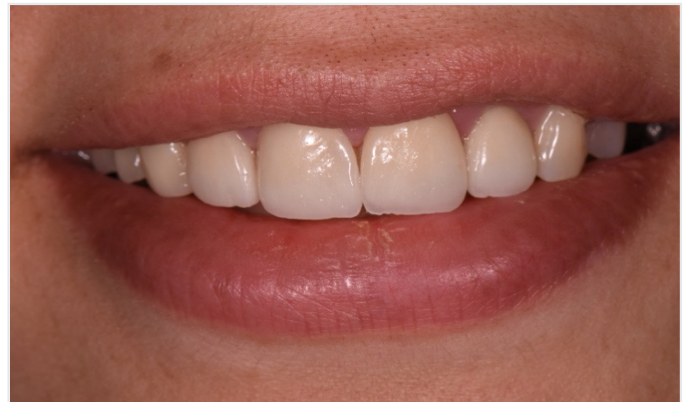
Figure 4. Post-cementation image of porcelain laminate veneers

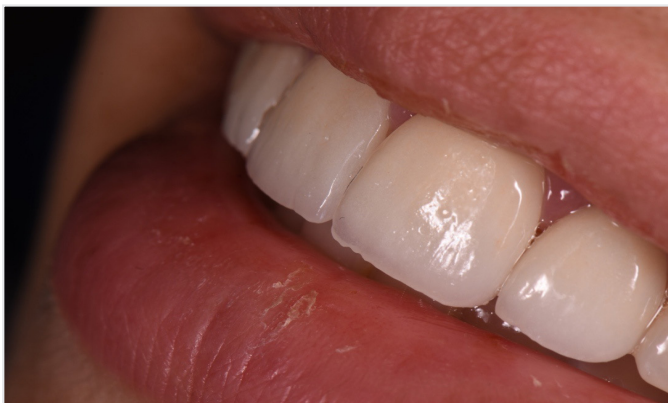
**Figure 5.** Finished porcelain laminate veneers

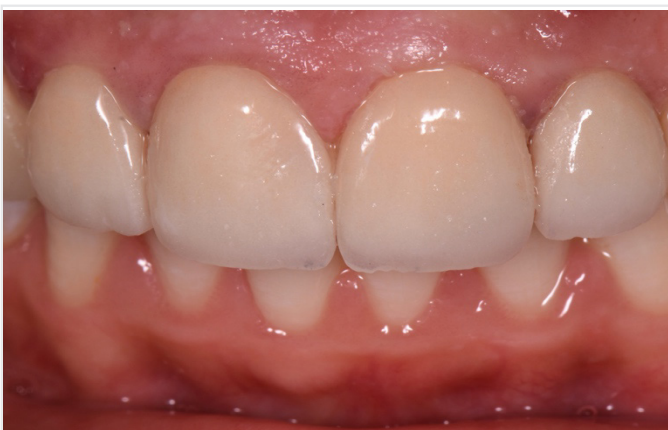
**Figure 6.** Image of porcelain laminate veneers at the end of 12 months follow-up
